# ASBESTOS DEMOLITION SURVEY REPORT

Edmund Rice Schools Trust

Meadow Vale

Project Number  
**27081**

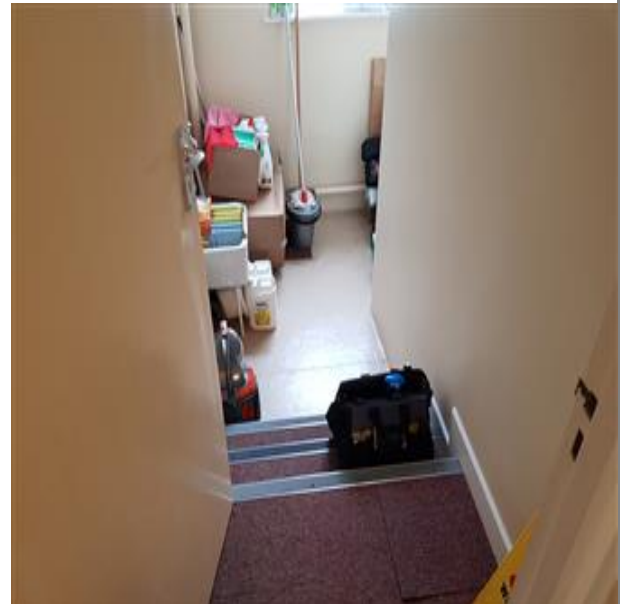
- Asbestos was found to be present within the floor tiles located within the store under the stairs on the ground floor.

<b>Risk Assessment</b>	338453	<b>Location</b>	RA:338453 Ground Floor Store under stairs Floor							
<b>Notes:</b>	Limited access due to the continued occupancy of the building.									
Type of Product	Quantity	Accessibility	Condition	Surface Treatment	Asbestos Type	Sample No.	Confirmation	MA	PA	Action
vinyl floor tile	--N\A--	--N\A--	Good condition	Composite materials containing asbestos	Chrysotile	RFB20190517004	Sample Taken	2	2	Priority 1 : Remove ACM's Prior to Refurbishment or Demolition.

Score	Risk Rating
Asbestos Type : Chrysotile	1	High Risk
Type Of Product : vinyl floor tile	1	Medium Risk
Condition : Good condition	0	Low Risk
Surface Treatment : Composite materials containing asbestos	0	Very Low Risk
<b>Material Assessment Score :</b>	<b>2</b>	<b>Very Low Risk</b>

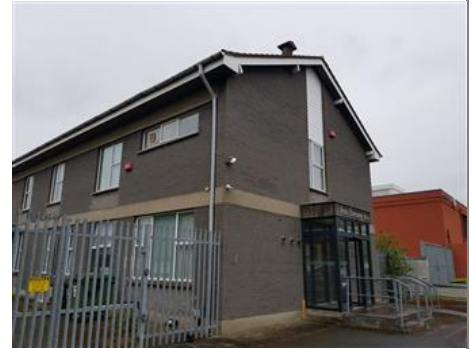
Building/Area : All Floors  
Room/Section : Exterior  
Location : Roof  
Description : Cement cloaker slates  
Sample No. :  
Confirmation : Presumed  
Access : Partial Access (Notes)  
Normal Use : Office Building  
Recommendations :  
No access to roof area.;

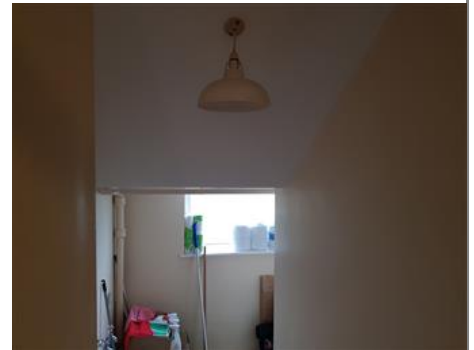
### Location Details 338454 No Asbestos Found

Building/Area : Ground Floor  
Room/Section : Store under stairs  
Location : Walls & Ceiling  
Description :  
Sample No. :  
Confirmation : --N\A--  
Access : Partial Access (Notes)  
Normal Use : Store  
Recommendations :  
Limited access due to the continued occupancy of the building.;

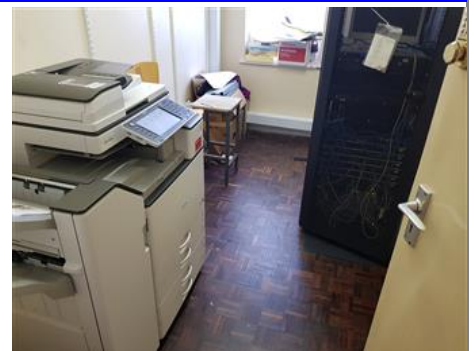
### Location Details 338455 No Asbestos Found

Building/Area : Ground Floor  
Room/Section : Room 2  
Location : Floor  
Description : Bitumen to parquet floor  
Sample No. : RFB20190517003  
Confirmation : Strongly presumed  
Access : Partial Access (Notes)  
Normal Use : Server Room  
Recommendations :  
Limited access due to the continued occupancy of the building.;

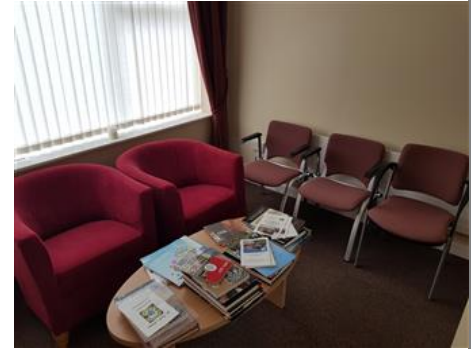
Building/Area : Ground Floor  
Room/Section : Room 1  
Location : Floor  
Description : Bitumen to parquet floor  
Sample No. : RFB20190517003  
Confirmation : Sample Taken  
Access : Partial Access (Notes)  
Normal Use : Waiting Area

Recommendations :  
Limited access due to the continued occupancy of the building.;

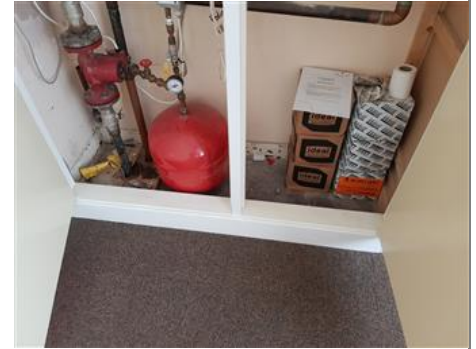
Building/Area : Ground Floor  
Room/Section : Room 1 Boiler Cupboard  
Location : Floor  
Description : Bitumen to parquet floor  
Sample No. : RFB20190517003  
Confirmation : Strongly presumed  
Access : Partial Access (Notes)  
Normal Use : Cupboard

Recommendations :  
Limited access due to the continued occupancy of the building.;

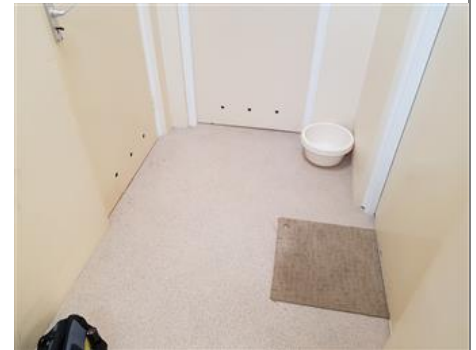
Building/Area : Ground Floor  
Room/Section : Lobby  
Location : Floor  
Description : Lino  
Sample No. : RFB20190517005  
Confirmation : Strongly presumed  
Access : Partial Access (Notes)  
Normal Use : Lobby

Recommendations :  
No intrusive access possible in the occupied building.;

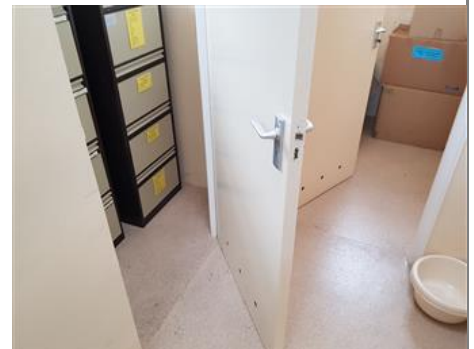
### Location Details 338466 No Asbestos Found

Building/Area : Ground Floor  
Room/Section : Lobby Stores  
Location : Floor  
Description : Lino  
Sample No. : RFB20190517005  
Confirmation : Strongly presumed  
Access : Partial Access (Notes)  
Normal Use : Stores  
Recommendations :  
Limited access beneath the fixed floor coverings.;

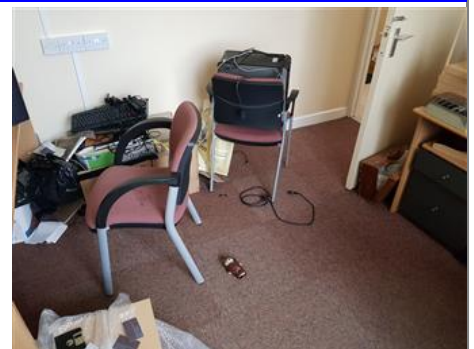
### Location Details 338467 No Asbestos Found

Building/Area : Ground Floor  
Room/Section : Room 4  
Location : Floor  
Description : Bitumen to parquet floor  
Sample No. : RFB20190517003  
Confirmation : Strongly presumed  
Access : Partial Access (Notes)  
Normal Use : Office  
Recommendations :  
No intrusive access possible in the occupied building.;

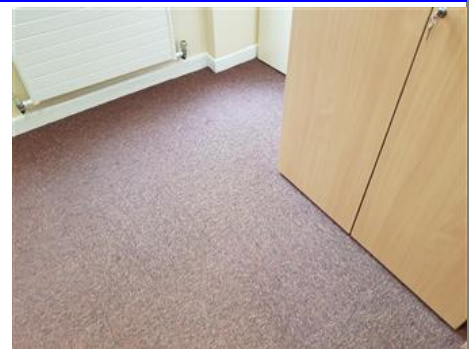
### Location Details 338487 No Asbestos Found

Building/Area : Ground Floor  
Room/Section : Room 3  
Location : Floor  
Description : Bitumen to parquet  
Sample No. : RFB20190517003  
Confirmation : Strongly presumed  
Access : Partial Access (Notes)  
Normal Use : Office  
Recommendations :  
No intrusive access possible in the occupied building.;

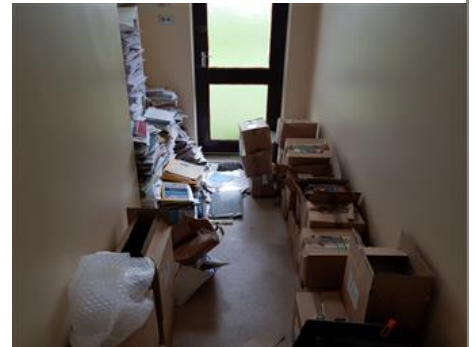
### Location Details 338472 No Asbestos Found

Building/Area : Ground Floor  
Room/Section : Lobby 1  
Location : Floor  
Description : Lino  
Sample No. : RFB20190517005  
Confirmation : Strongly presumed  
Access : Partial Access (Notes)  
Normal Use : Lobby  
Recommendations :  
Limited access due to the continued occupancy of the building.;

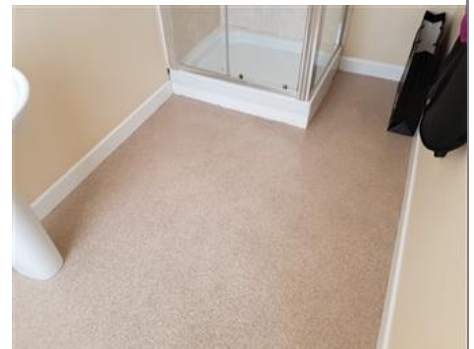
### Location Details 338477 No Asbestos Found

Building/Area : Ground Floor  
Room/Section : Room 5 Bathroom  
Location : Floor  
Description : Lino  
Sample No. : RFB20190517005  
Confirmation : Strongly presumed  
Access : Partial Access (Notes)  
Normal Use : Bathroom  
Recommendations :  
Limited access due to the continued occupancy of the building.;

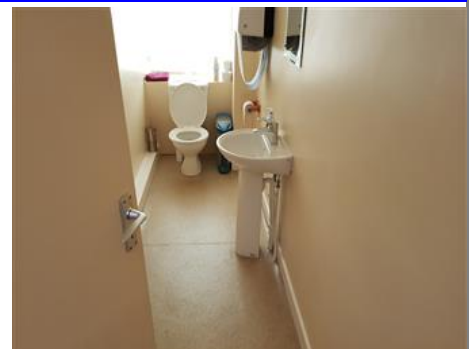
### Location Details 338478 No Asbestos Found

Building/Area : Ground Floor  
Room/Section : Toilet  
Location : Floor  
Description : Lino  
Sample No. : RFB20190517005  
Confirmation : Strongly presumed  
Access : Partial Access (Notes)  
Normal Use : Toilet  
Recommendations :  
Limited access due to the continued occupancy of the building.;

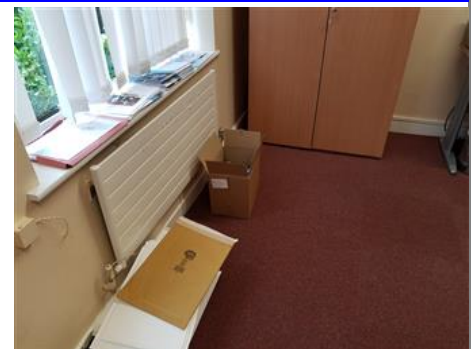
### Location Details 338481 No Asbestos Found

Building/Area : Ground Floor  
Room/Section : Reception  
Location : Floor  
Description : Bitumen to parquet  
Sample No. : RFB20190517003  
Confirmation : Strongly presumed  
Access : Partial Access (Notes)  
Normal Use : Reception  
Recommendations :  
No intrusive access possible in the occupied building.;

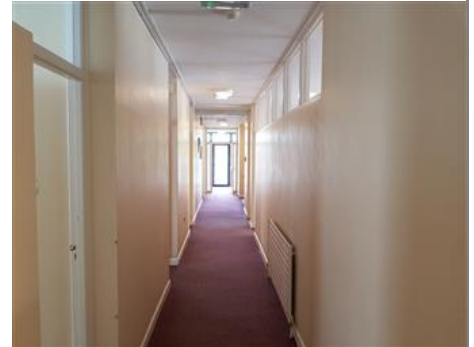
Building/Area : Ground Floor  
Room/Section : Corridor  
Location : Floor  
Description : Bitumen to parquet  
Sample No. : RFB20190517003  
Confirmation : Strongly presumed  
Access : Partial Access (Notes)  
Normal Use : Corridor  
Recommendations :  
No intrusive access possible in the occupied building.;
