Independent Tree Surveys

Tree Survey Report
Residential Development
Clonkeen
Blackrock
Co. Dublin

August 2021

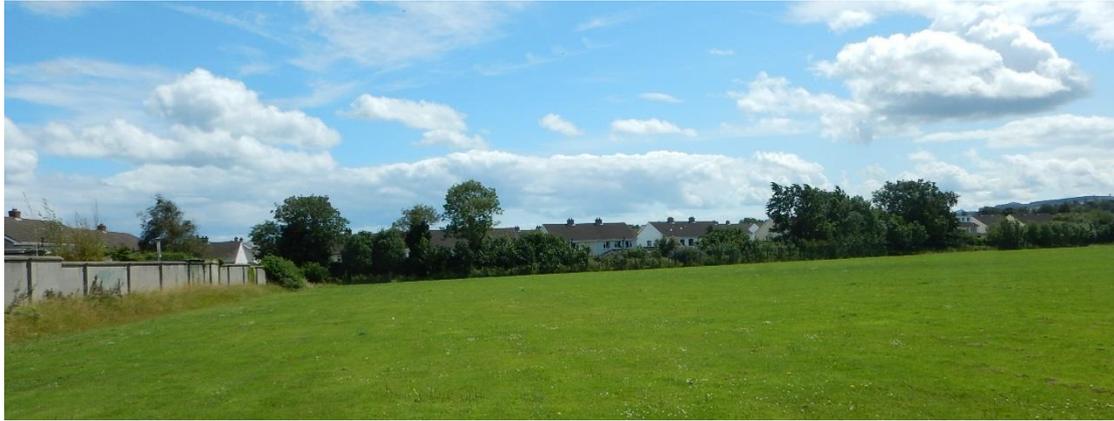
1. South-eastern boundary of the site viewed from the north-west; the larger trees and hedge-line originate outside the site.

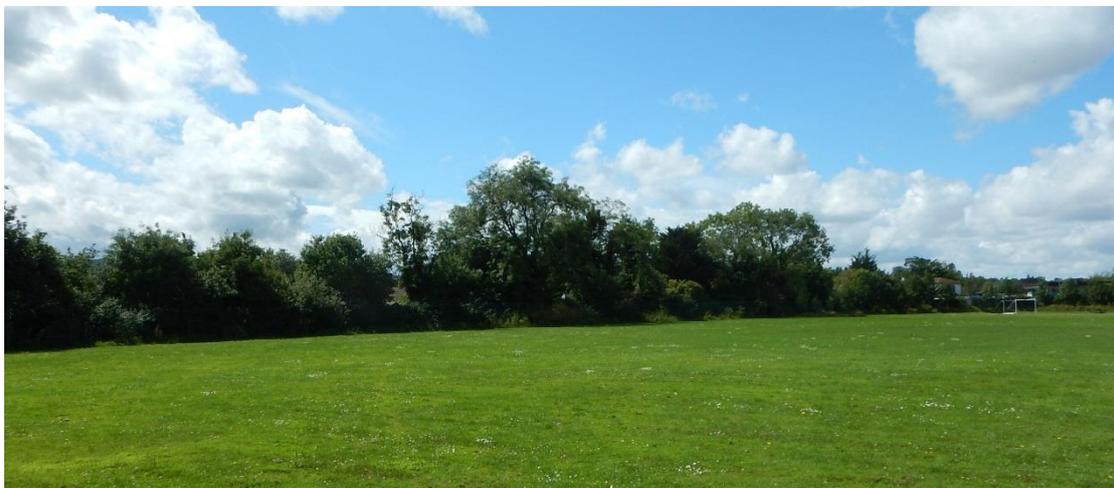
2. Southern boundary area; all significant tree and hedge growth originates on the southern side of the boundary ditch

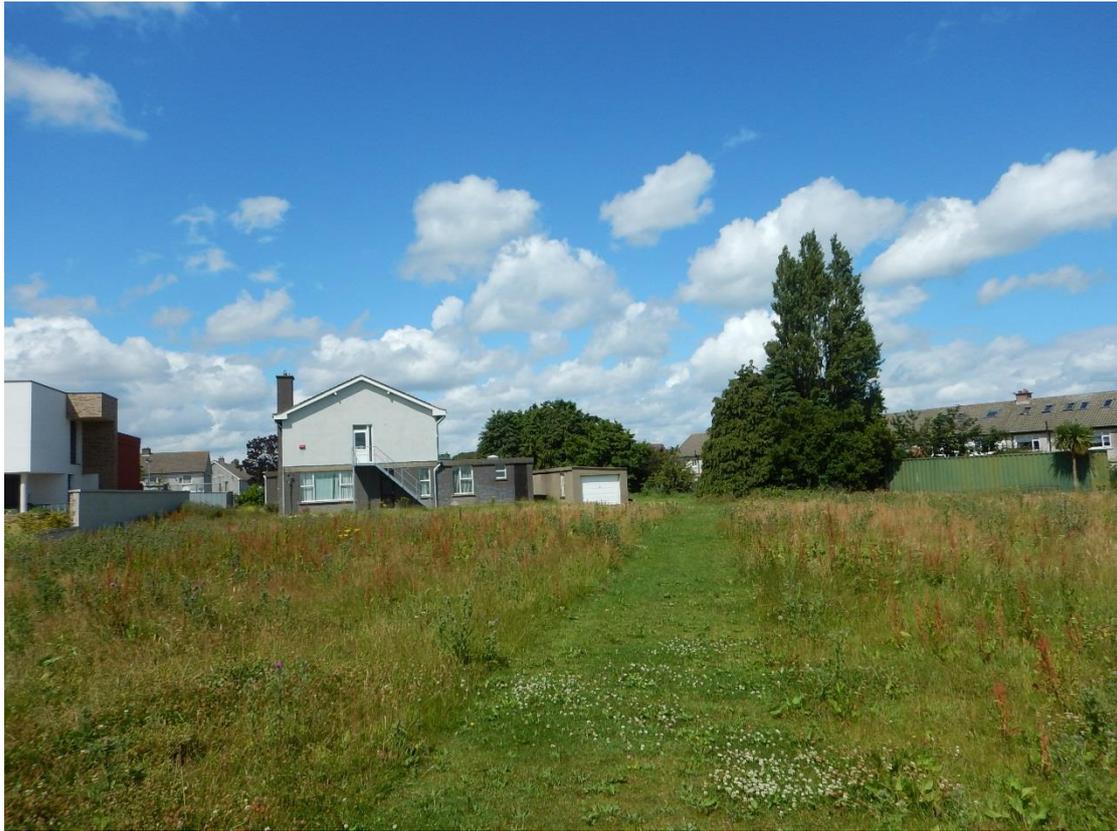
3. Trees and conifer hedges close to the ERST premises; viewed from the south

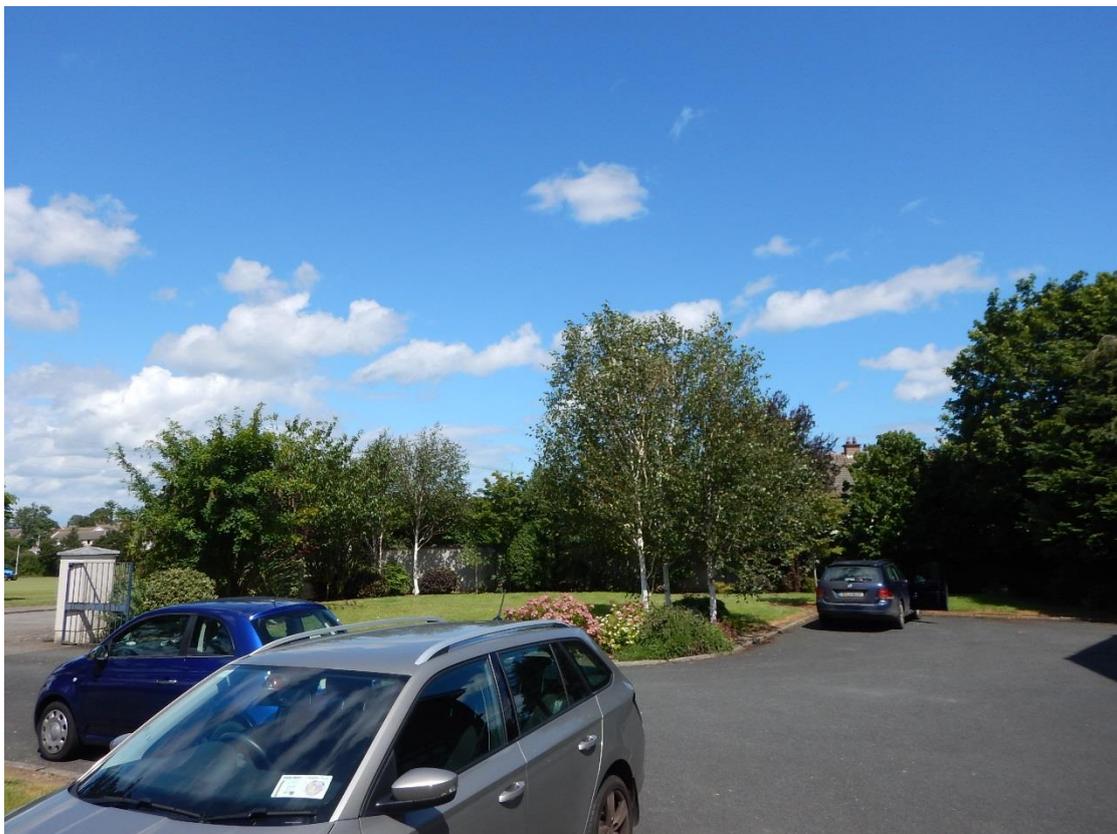
4. Young trees established in the front garden of the ERST premises.
