# ASBESTOS DEMOLITION SURVEY REPORT

Edmund Rice Schools Trust

Meadow Vale

Project Number  
**27081**

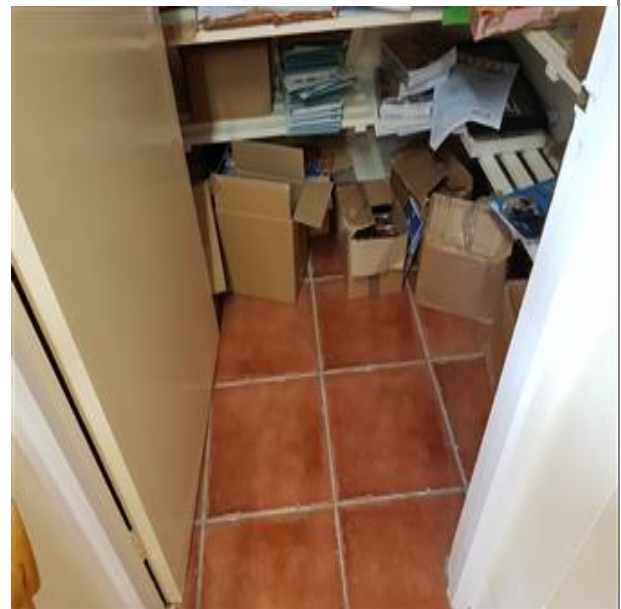
Asbestos Type : Presumed ACM Present  
Type Of Product : --N\A--  
Condition : --N\A--  
Surface Treatment : --N\A--

Priority 1 : Investigate prior to disturbing No intrusive access possible in the occupied building.

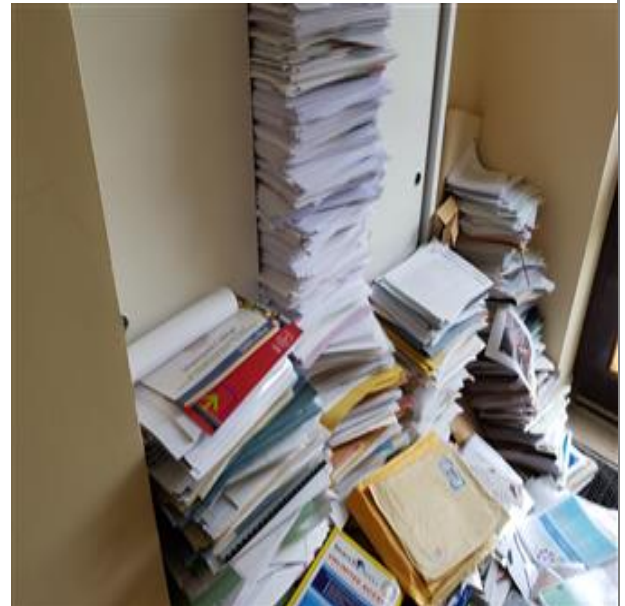
Asbestos Type : Presumed ACM Present  
Type Of Product : --N\A--  
Condition : --N\A--  
Surface Treatment : --N\A--

Priority 1 : Investigate prior to disturbing Limited access due to the continued occupancy of the building.

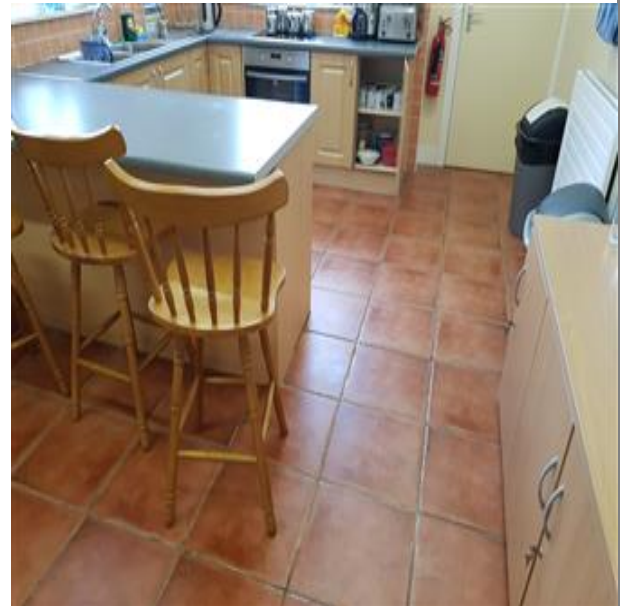
Asbestos Type : Presumed ACM Present  
Type Of Product : --N\A--  
Condition : --N\A--  
Surface Treatment : --N\A--

Priority 1 : Investigate prior to disturbing No access beneath fixed floor coverings in the occupied building.

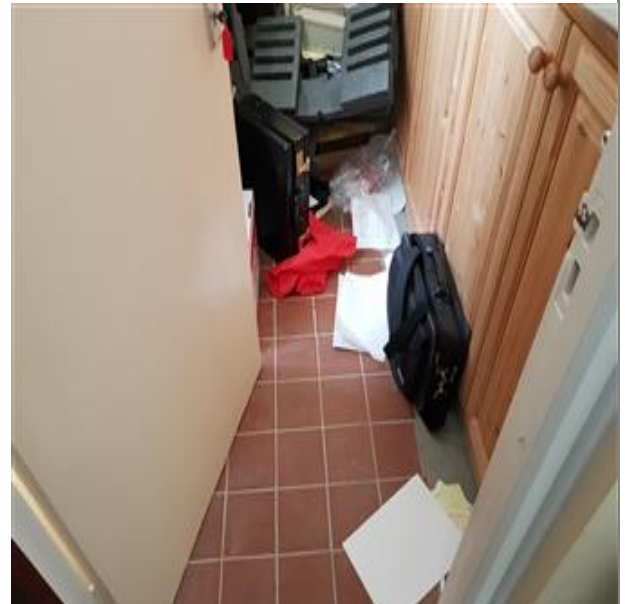
Asbestos Type : Presumed ACM Present  
Type Of Product : --N\A--  
Condition : --N\A--  
Surface Treatment : --N\A--

Priority 1 : Investigate prior to disturbing Limited access due to the continued occupancy of the building.

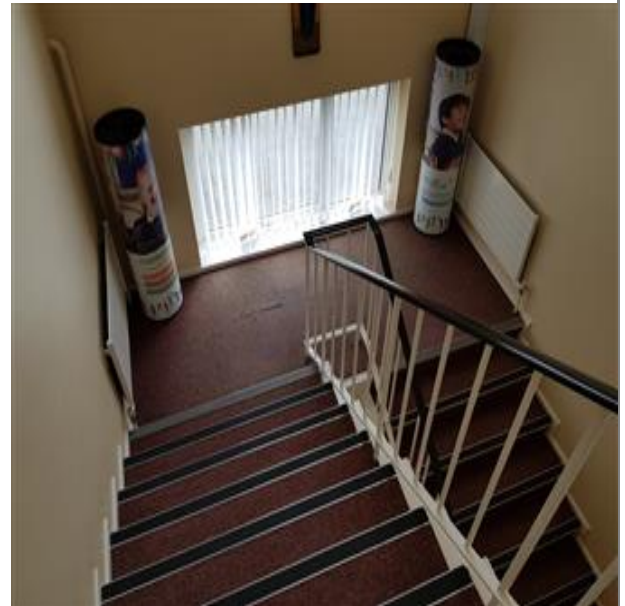
Asbestos Type : Presumed ACM Present  
Type Of Product : --N\A--  
Condition : --N\A--  
Surface Treatment : --N\A--

Priority 1 : Investigate prior to disturbing No intrusive access possible in the occupied building.

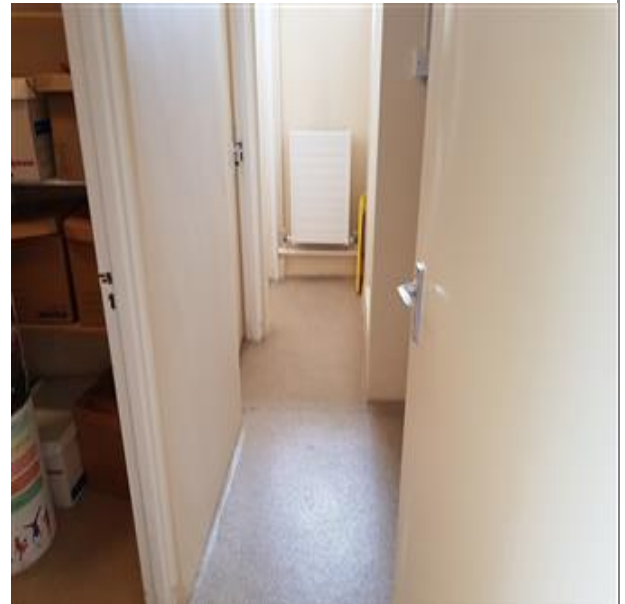
Score	Risk Rating
Asbestos Type : Presumed ACM Present	6	High Risk
Type Of Product : --N\A--	0	Medium Risk
Condition : --N\A--	0	Low Risk
Surface Treatment : --N\A--	0	Very Low Risk
<b>Material Assessment Score :</b>	<b>6</b>	<b>Low Risk</b>

Priority 1 : Investigate prior to disturbing No intrusive access possible in the occupied building.

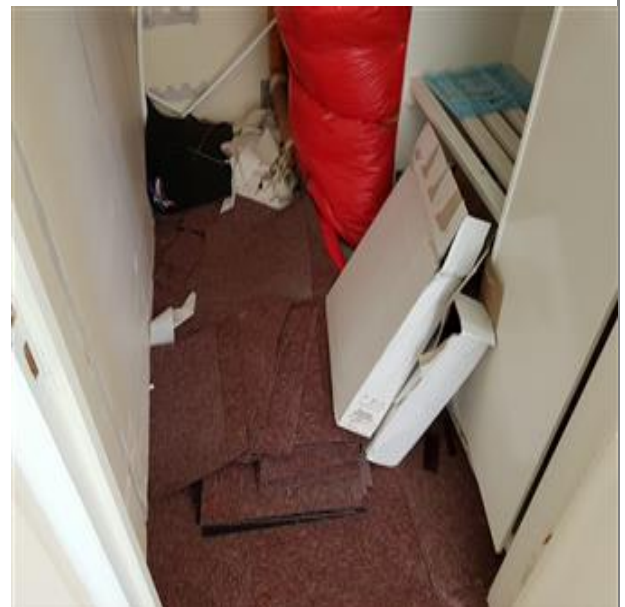
Score	Risk Rating
Asbestos Type : Presumed ACM Present	6	High Risk
Type Of Product : --N\A--	0	Medium Risk
Condition : --N\A--	0	Low Risk
Surface Treatment : --N\A--	0	Very Low Risk
<b>Material Assessment Score :</b>	<b>6</b>	<b>Low Risk</b>

Priority 1 : Investigate prior to disturbing No intrusive access possible in the occupied building.

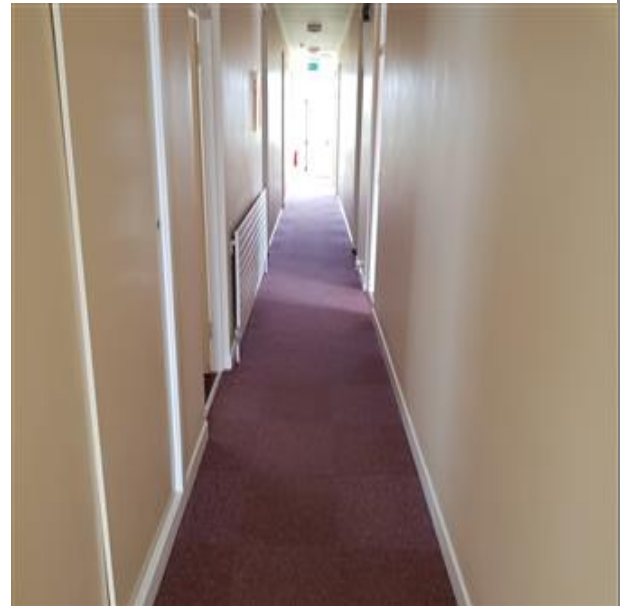
Asbestos Type : Presumed ACM Present  
Type Of Product : --N\A--  
Condition : --N\A--  
Surface Treatment : --N\A--

Priority 1 : Investigate prior to disturbing No intrusive access possible in the occupied building.

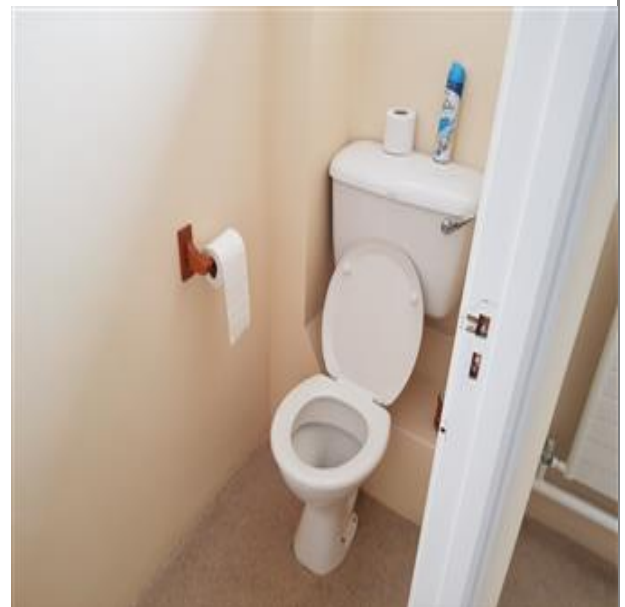
Asbestos Type : Presumed ACM Present  
Type Of Product : --N\A--  
Condition : --N\A--  
Surface Treatment : --N\A--

Priority 1 : Investigate prior to disturbing Limited access due to the continued occupancy of the building.

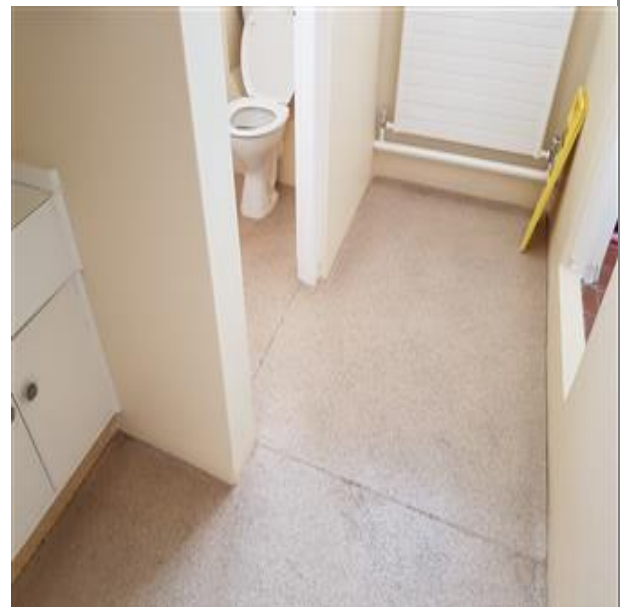
Score	Risk Rating
Asbestos Type : Presumed ACM Present	6	High Risk
Type Of Product : --N\A--	0	Medium Risk
Condition : --N\A--	0	Low Risk
Surface Treatment : --N\A--	0	Very Low Risk
<b>Material Assessment Score :</b>	<b>6</b>	<b>Low Risk</b>

Priority 1 : Investigate prior to disturbing No intrusive access possible in the occupied building.

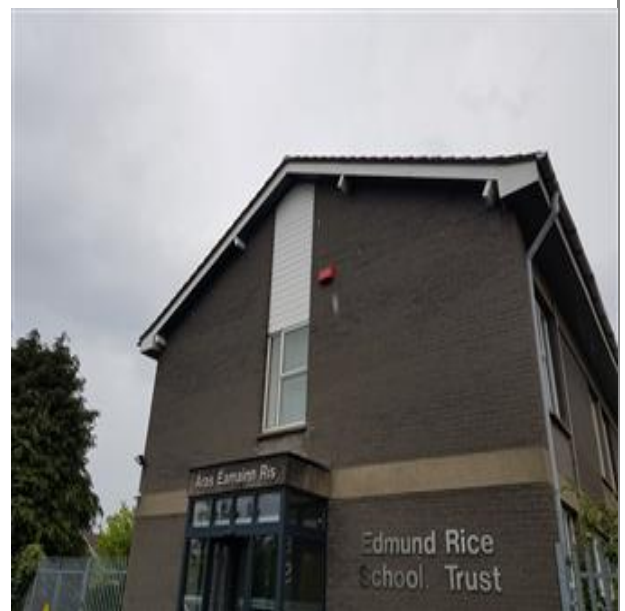
Score	Risk Rating
Asbestos Type : Presumed ACM Present	6	High Risk
Type Of Product : --N\A--	0	Medium Risk
Condition : --N\A--	0	Low Risk
Surface Treatment : --N\A--	0	Very Low Risk
<b>Material Assessment Score :</b>	<b>6</b>	<b>Low Risk</b>

Priority 1 : Investigate prior to disturbing Limited access due to the continued occupancy of the building.

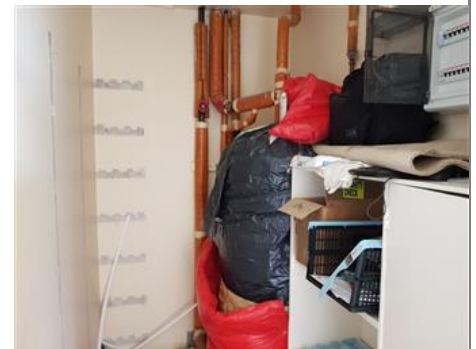
**Location Details 338500 No Asbestos Found**

Building/Area : First Floor  
Room/Section : Hot Press  
Location : Walls & Ceiling  
Description :  
Sample No. :  
Confirmation : --N\A--  
Access : Partial Access (Notes)  
Normal Use : Hot Press  
Recommendations :  
No intrusive access possible in the occupied building.;

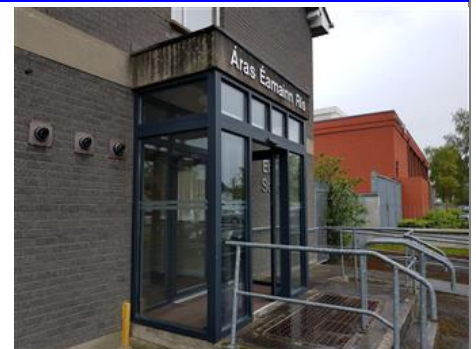
**Location Details 338524 No Asbestos Found**

Building/Area : All Floors  
Room/Section : Porch  
Location : Floor, Walls & Ceiling  
Description :  
Sample No. :  
Confirmation : --N\A--  
Access : Partial Access (Notes)  
Normal Use : Porch  
Recommendations :  
;

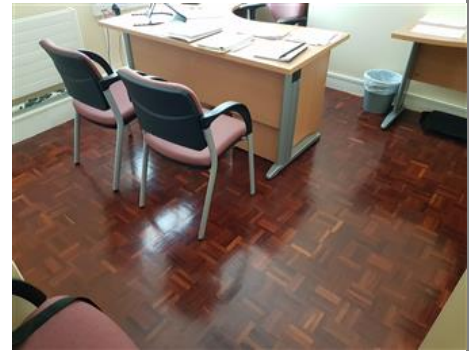
### Location Details 338492 No Asbestos Found

Building/Area : First Floor  
Room/Section : Room 6  
Location : Floor  
Description : Bitumen to parquet  
Sample No. : RFB20190517003  
Confirmation : Strongly presumed  
Access : Partial Access (Notes)  
Normal Use : Office  
Recommendations :  
No intrusive access possible in the occupied building.;

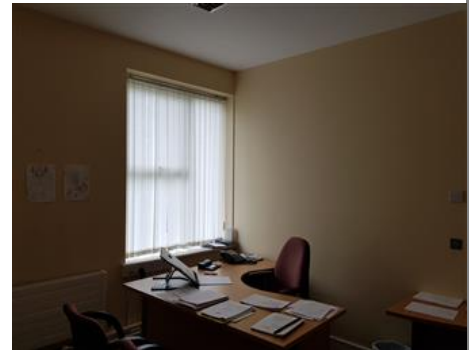
### Location Details 338493 No Asbestos Found

Building/Area : First Floor  
Room/Section : Room 6  
Location : Walls & Ceiling  
Description :  
Sample No. :  
Confirmation : --N\A--  
Access : Partial Access (Notes)  
Normal Use : Office  
Recommendations :  
No intrusive access possible in the occupied building.;

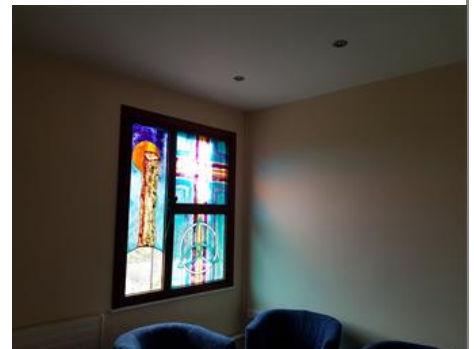
### Location Details 338494 No Asbestos Found

Building/Area : First Floor  
Room/Section : Room 7  
Location : Walls & Ceiling  
Description :  
Sample No. :  
Confirmation : --N\A--  
Access : Partial Access (Notes)  
Normal Use : Oratory  
Recommendations :  
No intrusive access possible in the occupied building.;

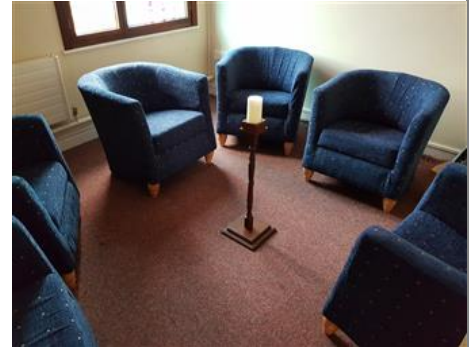
### Location Details 338495 No Asbestos Found

Building/Area : First Floor  
Room/Section : Room 7  
Location : Floor  
Description : Bitumen to parquet  
Sample No. : RFB20190517003  
Confirmation : Strongly presumed  
Access : Partial Access (Notes)  
Normal Use : Oratory

Recommendations :  
No intrusive access possible in the occupied building.;

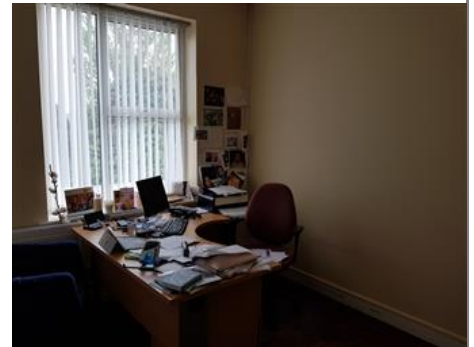
### Location Details 338496 No Asbestos Found

Building/Area : First Floor  
Room/Section : Room 8  
Location : Walls & Ceiling  
Description :  
Sample No. :  
Confirmation : --N\A--  
Access : Partial Access (Notes)  
Normal Use : Office

Recommendations :  
No intrusive access possible in the occupied building.;

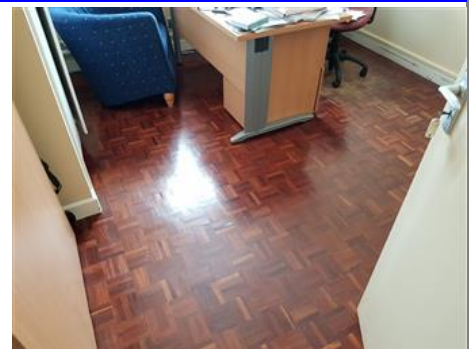
### Location Details 338497 No Asbestos Found

Building/Area : First Floor  
Room/Section : Room 8  
Location : Floor  
Description : Bitumen to parquet  
Sample No. : RFB20190517003  
Confirmation : Strongly presumed  
Access : Partial Access (Notes)  
Normal Use : Office

Recommendations :  
No intrusive access possible in the occupied building.;

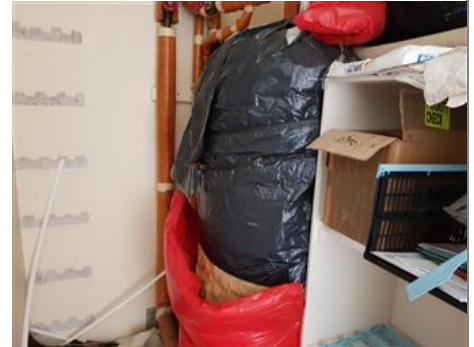
**Location Details 338502 No Asbestos Found**

Building/Area : First Floor  
Room/Section : Hot Press  
Location : Cylinder  
Description : Insulation  
Sample No. :  
Confirmation : --N\A--  
Access : Full Access  
Normal Use : Hot Press  
Recommendations :

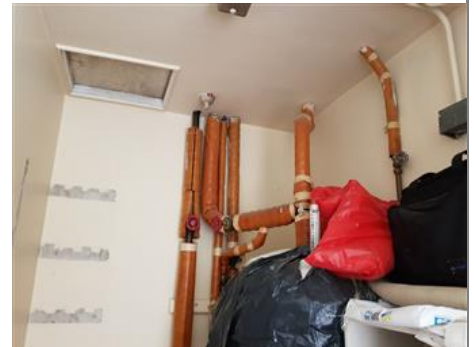
**Location Details 338503 No Asbestos Found**

Building/Area : First Floor  
Room/Section : Hot Press  
Location : Pipework  
Description : Insulation  
Sample No. :  
Confirmation : --N\A--  
Access : Full Access  
Normal Use : Hot Press  
Recommendations :

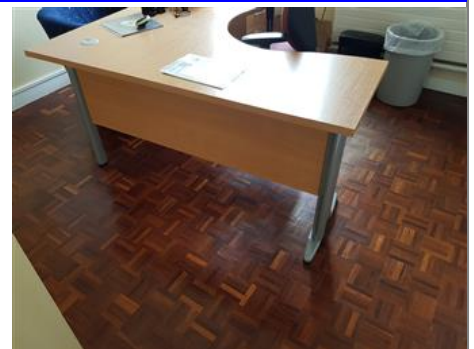
**Location Details 338504 No Asbestos Found**

Building/Area : First Floor  
Room/Section : Room 9  
Location : Floor  
Description : Bitumen to parquet  
Sample No. : RFB20190517003  
Confirmation : Strongly presumed  
Access : Partial Access (Notes)  
Normal Use : Office  
Recommendations :  
No intrusive access possible in the occupied building.;

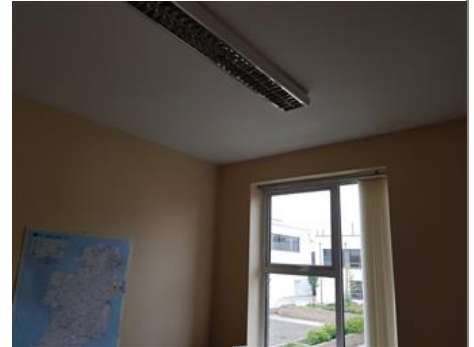
### Location Details 338505 No Asbestos Found

Building/Area : First Floor  
Room/Section : Room 9  
Location : Walls & Ceiling  
Description :  
Sample No. :  
Confirmation : --N\A--  
Access : Partial Access (Notes)  
Normal Use : Office  
Recommendations :  
No intrusive access possible in the occupied building.;

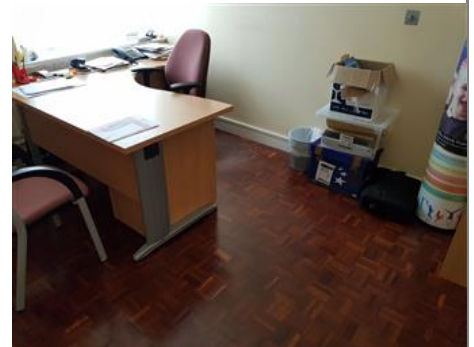
### Location Details 338506 No Asbestos Found

Building/Area : First Floor  
Room/Section : Room 10  
Location : Floor  
Description : Bitumen to parquet  
Sample No. : RFB20190517003  
Confirmation : Strongly presumed  
Access : Partial Access (Notes)  
Normal Use : Office  
Recommendations :  
No intrusive access possible in the occupied building.;

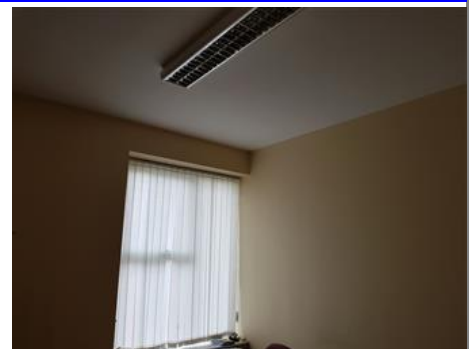
### Location Details 338507 No Asbestos Found

Building/Area : First Floor  
Room/Section : Room 10  
Location : Walls & Ceiling  
Description :  
Sample No. :  
Confirmation : --N\A--  
Access : Partial Access (Notes)  
Normal Use : Office  
Recommendations :  
No intrusive access possible in the occupied building.;

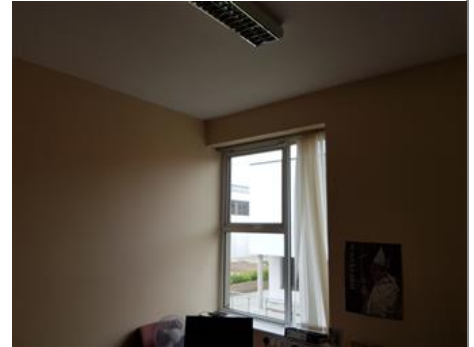
### Location Details 338508 No Asbestos Found

Building/Area : First Floor  
Room/Section : Room 11  
Location : Walls & Ceiling  
Description :  
Sample No. :  
Confirmation : --N\A--  
Access : Partial Access (Notes)  
Normal Use : Office  
Recommendations :  
No intrusive access possible in the occupied building.;

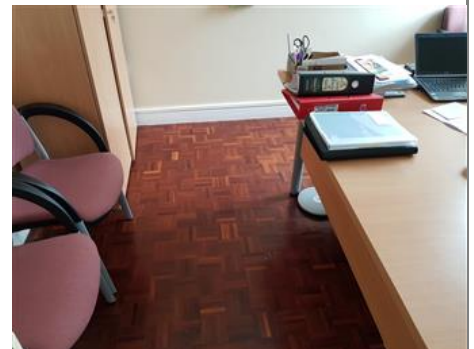
### Location Details 338509 No Asbestos Found

Building/Area : First Floor  
Room/Section : Room 11  
Location : Floor  
Description : Bitumen to parquet  
Sample No. : RFB20190517003  
Confirmation : Strongly presumed  
Access : Partial Access (Notes)  
Normal Use : Office  
Recommendations :  
No intrusive access possible in the occupied building.;

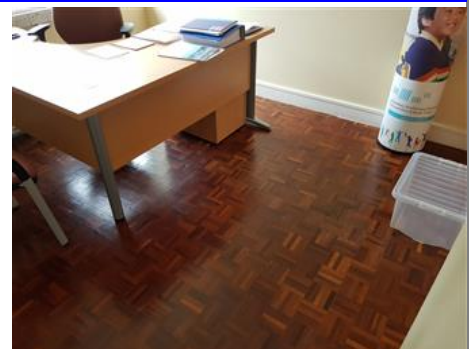
### Location Details 338510 No Asbestos Found

Building/Area : First Floor  
Room/Section : Room 12  
Location : Floor  
Description : Bitumen to parquet  
Sample No. : RFB20190517003  
Confirmation : Strongly presumed  
Access : Partial Access (Notes)  
Normal Use : Office  
Recommendations :  
No intrusive access possible in the occupied building.;

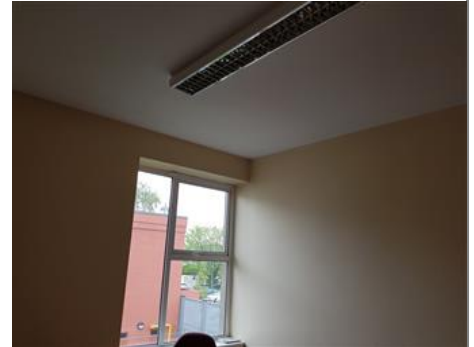
### Location Details 338511 No Asbestos Found

Building/Area : First Floor  
Room/Section : Room 12  
Location : Walls & Ceiling  
Description :  
Sample No. :  
Confirmation : --N\A--  
Access : Partial Access (Notes)  
Normal Use : Office  
Recommendations :  
No intrusive access possible in the occupied building.;

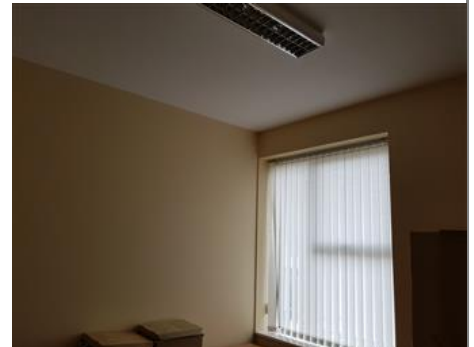
### Location Details 338512 No Asbestos Found

Building/Area : First Floor  
Room/Section : Room 13  
Location : Walls & Ceiling  
Description :  
Sample No. :  
Confirmation : --N\A--  
Access : Partial Access (Notes)  
Normal Use : Office  
Recommendations :  
No intrusive access possible in the occupied building.;

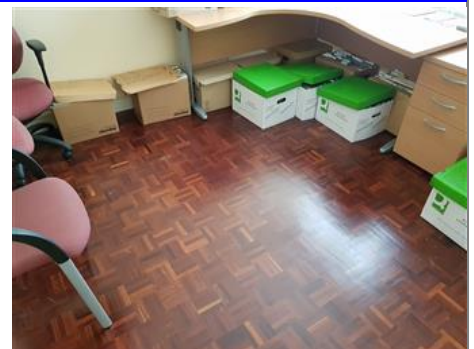
### Location Details 338513 No Asbestos Found

Building/Area : First Floor  
Room/Section : Room 13  
Location : Floor  
Description : Bitumen to parquet  
Sample No. : RFB20190517003  
Confirmation : Strongly presumed  
Access : Partial Access (Notes)  
Normal Use : Office  
Recommendations :  
No intrusive access possible in the occupied building.;

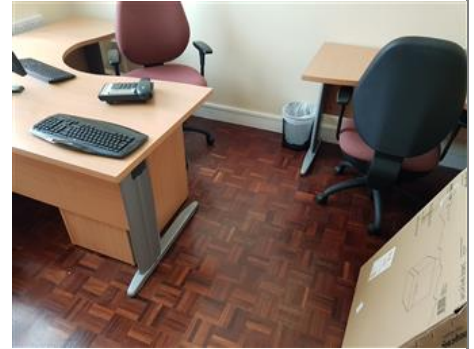
### Location Details 338514 No Asbestos Found

Building/Area : First Floor  
Room/Section : Room 14  
Location : Floor  
Description : Bitumen to parquet  
Sample No. : RFB20190517003  
Confirmation : Strongly presumed  
Access : Partial Access (Notes)  
Normal Use : Office  
Recommendations :  
No intrusive access possible in the occupied building.;

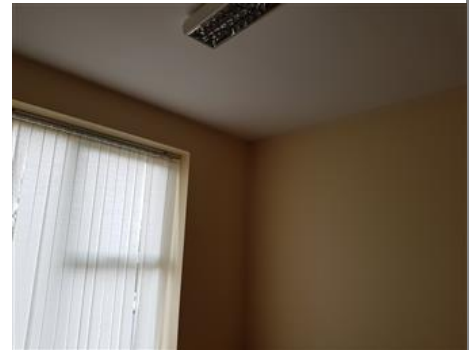
### Location Details 338515 No Asbestos Found

Building/Area : First Floor  
Room/Section : Room 14  
Location : Walls & Ceiling  
Description :  
Sample No. :  
Confirmation : --N\A--  
Access : Partial Access (Notes)  
Normal Use : Office  
Recommendations :  
No intrusive access possible in the occupied building.;

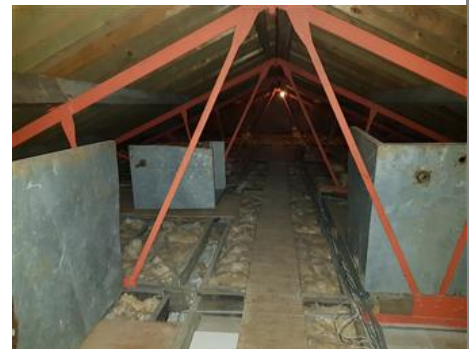
### Location Details 338516 No Asbestos Found

Building/Area :  
Room/Section : Attic  
Location : Floor & Roof  
Description :  
Sample No. :  
Confirmation : --N\A--  
Access : Partial Access (Notes)  
Normal Use : Attic  
Recommendations :  
No access to roof felt.;

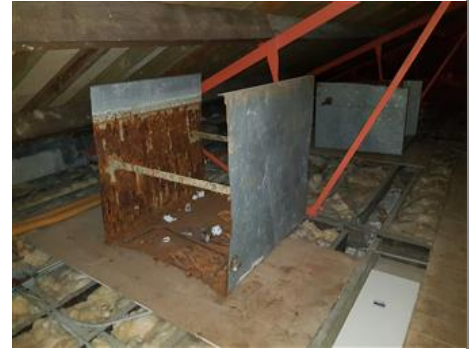
### Location Details 338517 No Asbestos Found

Building/Area :  
Room/Section : Attic  
Location : Old water tanks  
Description : Metal construction  
Sample No. :  
Confirmation : --N\A--  
Access : Full Access  
Normal Use : Attic  
Recommendations :  
;

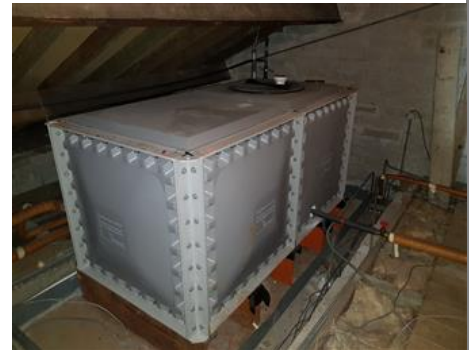
### Location Details 338518 No Asbestos Found

Building/Area :  
Room/Section : Attic  
Location : New Water Tank  
Description : Modern construction  
Sample No. :  
Confirmation : --N\A--  
Access : Full Access  
Normal Use : Attic  
Recommendations :  
;

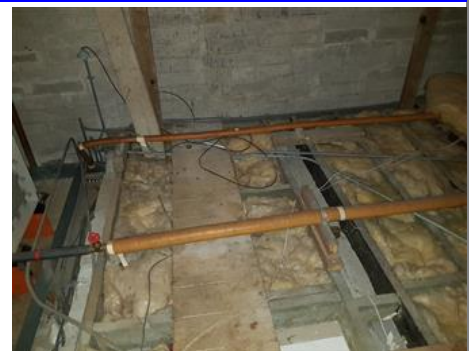
### Location Details 338519 No Asbestos Found

Building/Area :  
Room/Section : Attic  
Location : Pipework  
Description : Insulation  
Sample No. : RFB20190517006  
Confirmation : Sample Taken  
Access : Full Access  
Normal Use : Attic  
Recommendations :  
;

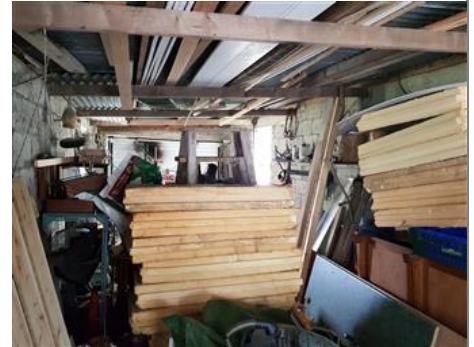
**Location Details 338520 No Asbestos Found**

Building/Area :  
Room/Section : Garage  
Location : Floor, Walls & Ceiling  
Description :  
Sample No. :  
Confirmation : --N/A--  
Access : Full Access  
Normal Use : Garage  
Recommendations :  
;
